Best Practice Guide - Compaction & Backfill

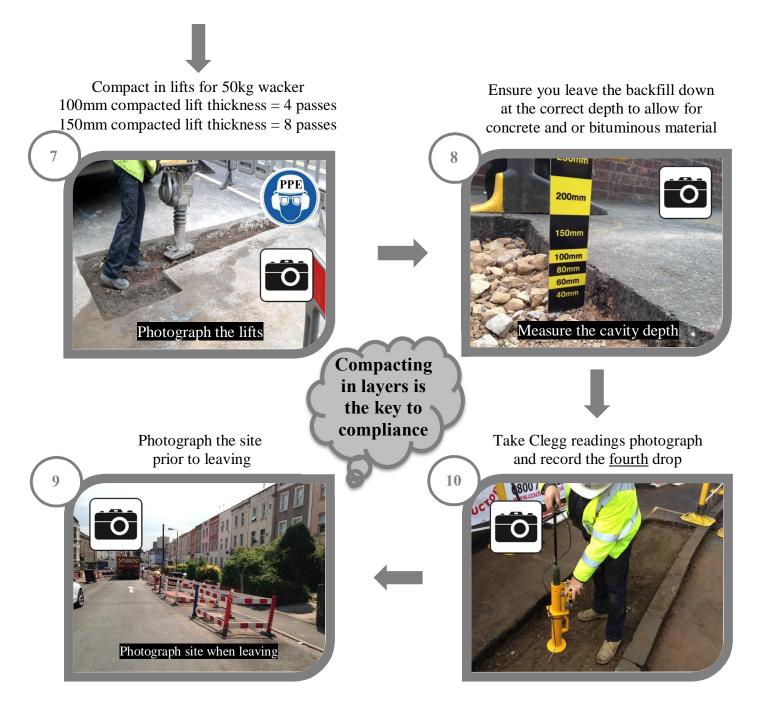
Reinstatement	Fourth Drop Impact Value		
Level	Target Value	Typical Range	Highest Likely
Trench Bed	7	7 ó 8	30
Top of Finefill	10	10 ó 17	-
Top of Backfill	18	17 - 27	-
Top of Subbase	22	24 - 27	-
Top of Roadbase	30	32 - 34	38
